**International Safety Products**

**SERVICE BULLETIN**

Bulletin N° **002/Jan/09**

### SAFETY INFORMATION

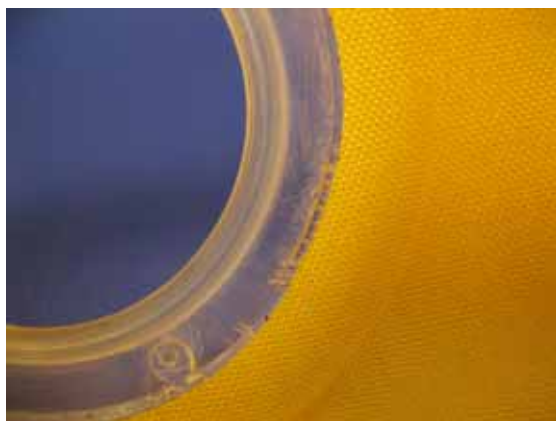
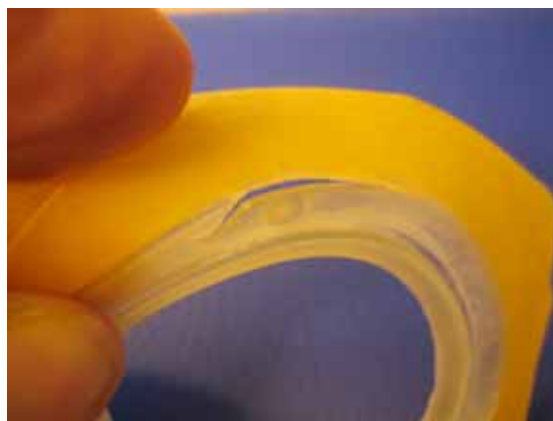
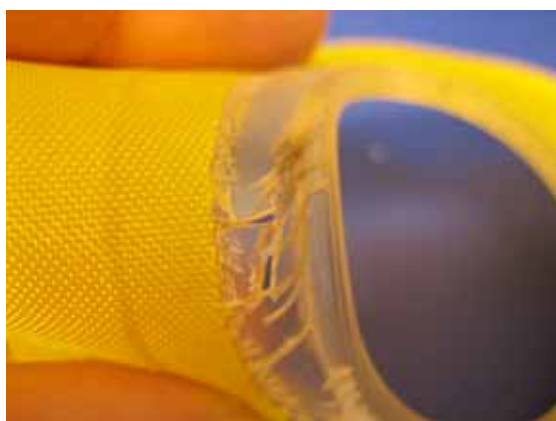
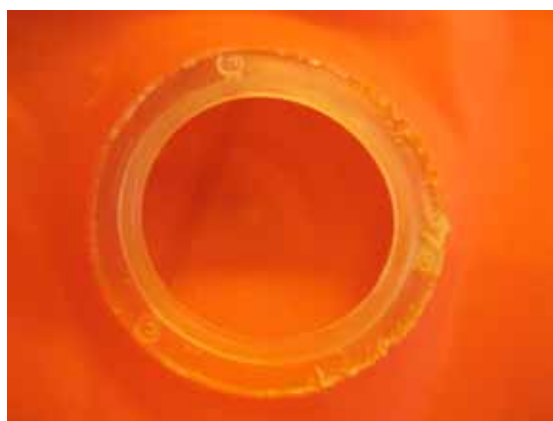
A small number of Sealing rings, manufactured before 2005/04 have, probably after being exposed to extreme environmental conditions (i.e. the life jacket is stored in very high temperature and moist environments ), experienced a premature degradation of the material. The Sealing Ring will become stiffer, change in colour and might in severe cases even crack or burst. The change does not happen "overnight" and can be detected at the regular service or inspections. Please also look at the attached photos:

The problem first came to our knowledge in the end of 2004. We examined the damaged Sealing Rings at SP, Chalmers and IFP (established Test Houses and Institute in Gothenburg). The results of the tests gave no reason for a recall or alarm, but revealed that new improved alternative material were available on the market. Based on the result of these examinations we altered our material and production process. We did send out a Technical Update 2005 (enclosed) where we informed about the change in material and design and also stressed the necessity of annual inspections.

We have not heard about any problem of this kind since 2005, but the problem has now been noted again on a very small number of life jackets. We therefore urge any one who carries out service on life jackets carrying the Hammar Inflator to pay extra attention to the condition of the sealing ring at the yearly service. If you find any Sealing Rings with degraded material, please report this immediately back to CM Hammar AB. We will then, together with you, discuss how to handle the situation.
