SERVICE BULLETIN

Bulletin N° 013/Dec/14

Hammar have issued a Safety Information bulletin regarding fake labels being put onto Hammar A1 Inflators.

Fake top labels on the Hammar inflator A1 for Inflatable lifejackets have been discovered on the market.

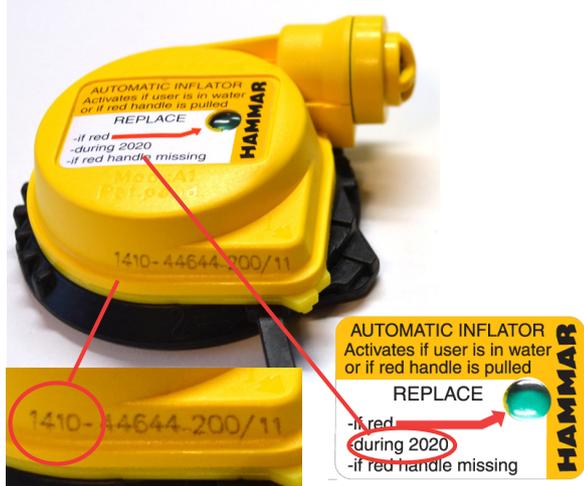
ORIGINAL

- A Hammar inflator is marked with a manufacturing date on the side of the inflator cap. The first four digits describe which year and month (YYMM) is has been manufactured. When comparing the manufacturing date and replace during (expiry date) the interval is between 5 years and 6,5 years (due to leadtime and storage).
- There is a visual difference between the original and fake top label.
 - Colour
 - Logotype
 - Type of material

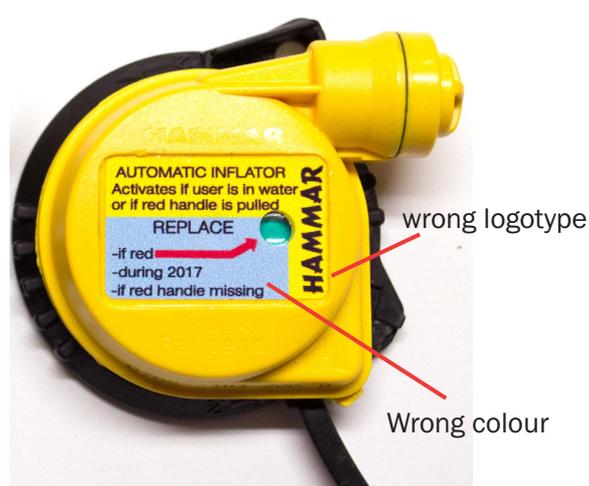
FAKE

It has recently come to our attention that someone has removed and replaced the original top label on Hammar inflators A1. The fake label has an additional five years life to extend the expiry date.
