**International Safety Products**

**SERVICE BULLETIN**

Bulletin N° **002/Jan/09**

### SAFETY INFORMATION

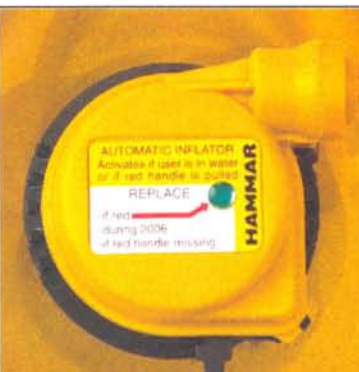
### PERIODICAL CHECKING

- Check that the single point indicator is green
- Check that the expiry date is within the limit
- Check that the red handle is attached

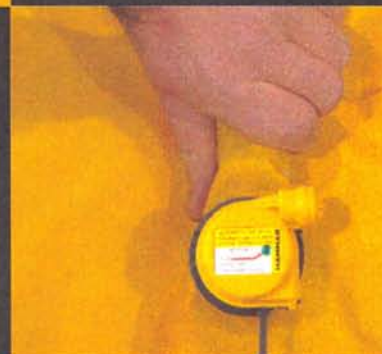
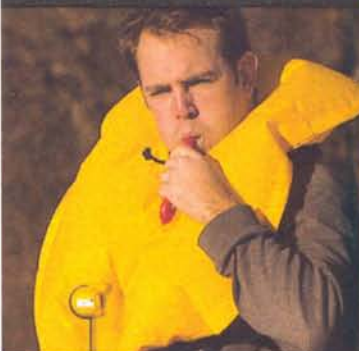
### CHECK THAT THE GAS CYLINDER

is firmly tightened by holding it through the lifejacket fabric. We recommend this checking to be part of the donning procedure.

- The frequency of the checking must take into account:
- Frequency and duration of use
- Activity level of the individual wearing the lifejacket
- Lifejackets using 60 grams cylinders due to the increased diameter
- Check also any specific instructions from the lifejacket manufacturer
