International Safety Products

SERVICE BULLETIN

Bulletin N° **003/june/09**

All ISP manufactured products including Lifejackets and Bladder Assemblies fitted with **HALKEY ROBERTS BLACK MOULDED MANIFOLDS**

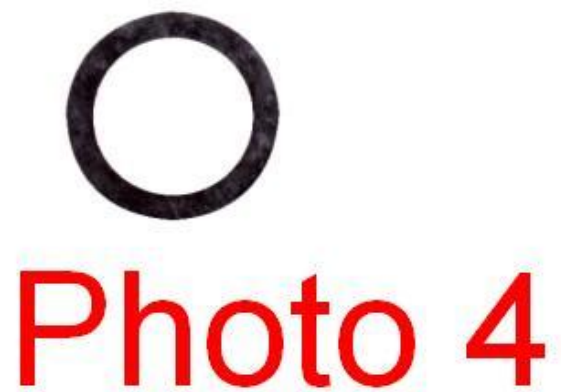
If replacing the inflator on an ISP manufactured product and the manifold is the black coloured moulded style (see photo 1), *and* if the inflator being fitted is either a Halkey Roberts Manual "840 series" Inflator (see photo 2), OR a Halkey Roberts Auto "85000 series" Inflator (see photo 3), then you should use 2 x of the same model manifold gasket for both "upper" and "lower" sealing washers (see photo 4), i.e. place the first gasket washer onto the base of the manifold, then place the inflator into position, then fit the other same size gasket washer, and then finally the cap nut and torque down.

The ISP Part Number for the gasket washer is 90-ISP-9IX-044
